# CENTER LAKE DIAGNOSTIC STUDY REPORT

**CENTER LAKE CONSERVATION ASSOCIATION, INC.  
&  
INDIANA DEPARTMENT OF NATURAL RESOURCES**

**V3 CONSULTANTS**  
7325 JANES AVENUE, SUITE 100  
WOODRIDGE, ILLINOIS 60517  
630.724.9200

**JANUARY 20, 2005**

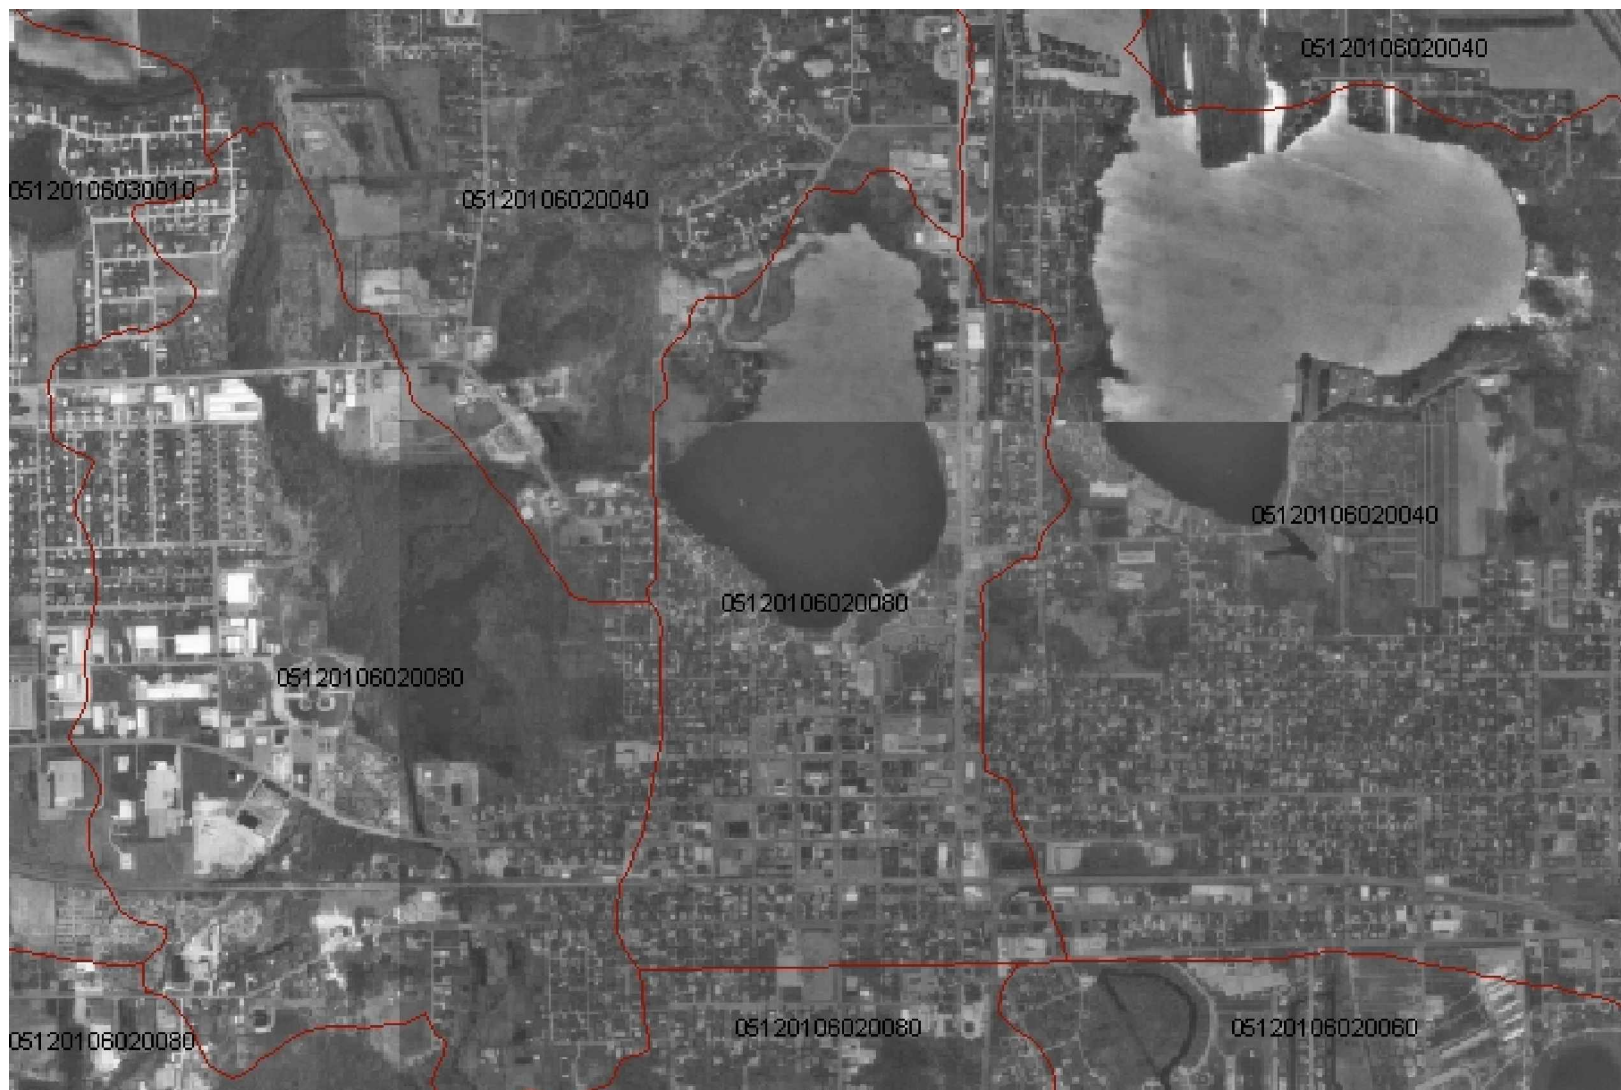
Client:	Title: Hydrologic Unit Exhibit		Project: Center Lake	
	Center Lake Conservation Association	Project No. 02218	Figure: 2	Sheet: 1 Of: 1
		File Name: N/A	Effective Date: 1/08/03	Scale: NTS

The Center Lake watershed has many atypical hydrologic features due to alterations that have taken place with regard to manipulation of surface water connections. Figure 4 shows several of the man-made alterations to the watershed. Figures 5 and 6 show the parts of the watershed as they existed in 1876. Most notably, the Tippecanoe River has been channelized and no longer converges with Walnut Creek and the Center Lake outfall just to the west of the south end of Center Lake. Walnut Creek now connects just downstream of the Fox Farm Road Crossing of the Tippecanoe River.

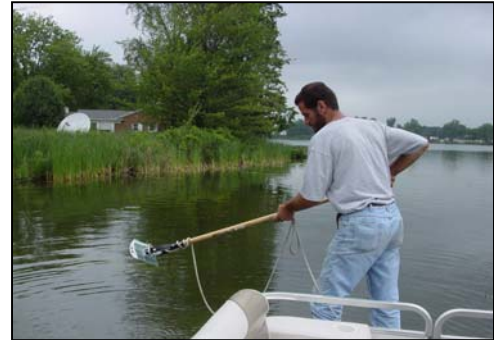
**Photo 2 – V3 ecologist collects aquatic plants**

The sampling technique used both visual estimates and rake grabs to identify the species abundances. The sampling site included an imaginary two-meter arc around the bow and the sides of the boat. The sampling site is separated in half, so that each sampling site contained two separate areas or sub-sample sites. This allowed collection of two sets of data at each site.

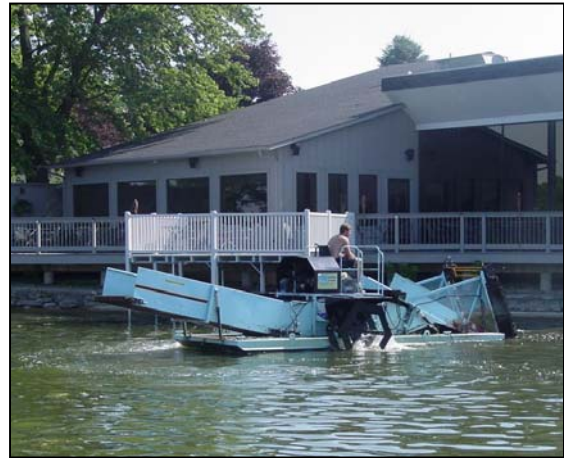
**Photo 3 – CLCA’s Weed Harvester**

Mechanical control using a harvester, which is owned by the CLCA (Photo 3), has been employed at Center Lake to open boating lanes. The harvester has also been used to control Eurasian water-milfoil and coontail, to a lesser degree. The harvester removes the plants from the water, which lessens water quality problems resulting from the decay of cut plants left in the water. The harvester cuts the vegetation while moving in the water, removes the cut plant material with a conveyor system and can dispose the plant material at an offshore location. The advantages of this control method are:

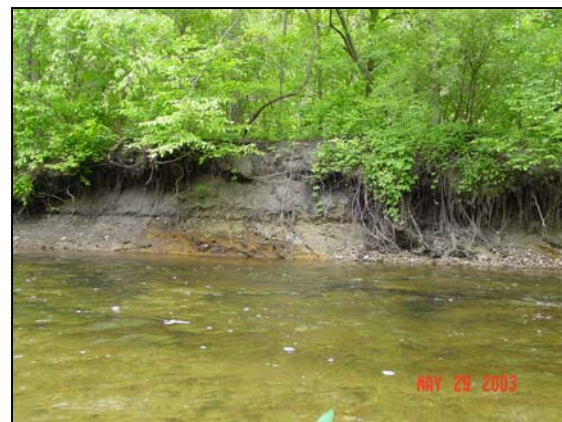
**Photo 6 – Severe bank erosion, Tippecanoe River**

In addition to the streambank erosion along the Tippecanoe River, silt also erodes from upland locations and agricultural lands within the watershed. This adds to the magnitude of silt that is carried in the Tippecanoe River as bedload and is the source of the sedimentation problem that is occurring within the channel north of Center Lake as well as the northwestern portions of Center Lake itself.

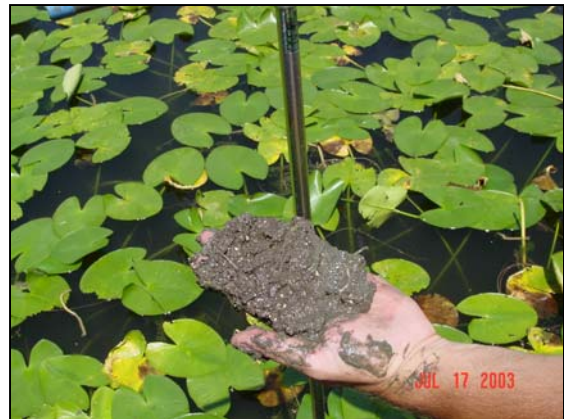
**Photo 7 – Lake Sediment**

This channelized section extending north of Center Lake does possess a significant amount of deposited sediment. This can be seen by the sediment plumes that are created by boat propellers. This channel receives limited water flow through it, occasionally the flow is into the lake and sometimes the flow is out from the lake, but for the most part the water remains stagnant. Members of the CLCA and V3 kayaked within the surface water connections to Center Lake on May 31, 2003. The turbidity levels in the waters from Lones Ditch (Pike Lake outlet) and the channel north of Center Lake were easily observed. By placing a paddle into the sediment one could release the gasses produced by decaying materials from within the sediment. The north channel was dredged south (the lake side) of the control structure in order to create it and has not been maintained by subsequent dredging since its creation. The channel north of the control structure, which connects to Lones Ditch, has never been dredged. The sediment of Center Lake is shown in Photo 7.
